9.2 Additions and Alterations to Heritage Buildings (Class A)

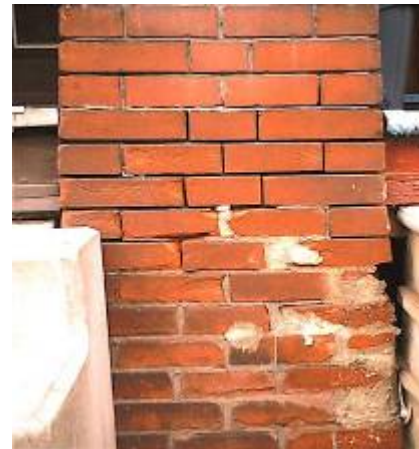
Progressive deterioration: Rainwater splashing on the porch and steps eroded the mortar. That let increasing amounts of water into the bricks and mortar below, and they are spalling and washing away, letting in even more moisture.

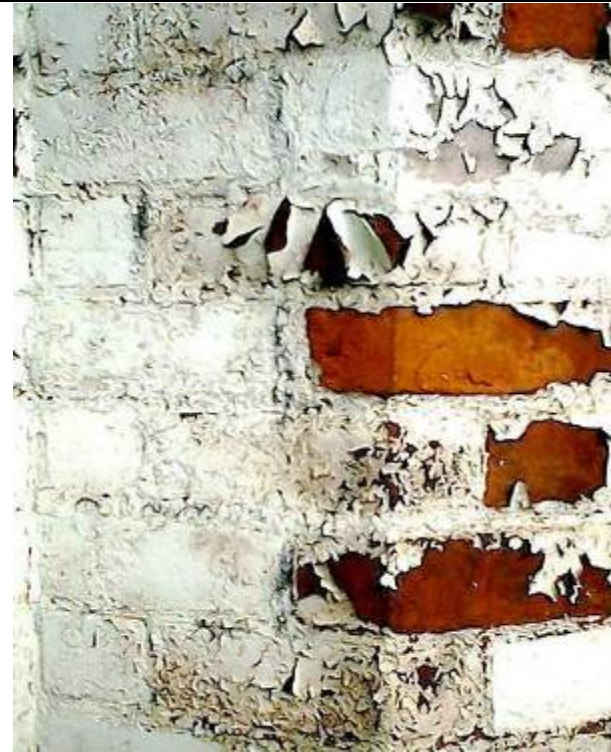
Non-breathing paint on brick. The vapour pressure of moisture in the brick blisters the paint, when it is able. If the paint adheres strongly, the pressure causes the brick surface to spall off, along with the paint, as seen in the centre of the picture. This lets in even more moisture, and the problem grows

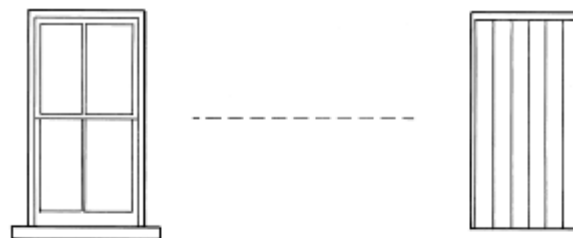
Not Appropriate: Original historical window boarded up rather than restored or replaced.

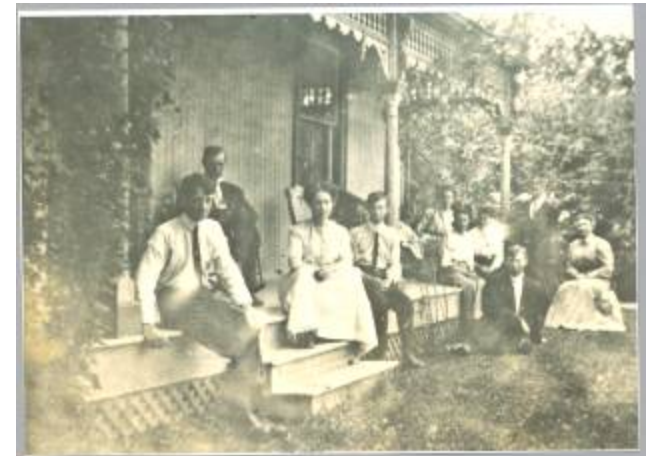
Late 19th century veranda on the Hood Farmhouse.
Casella Historical Collection #43

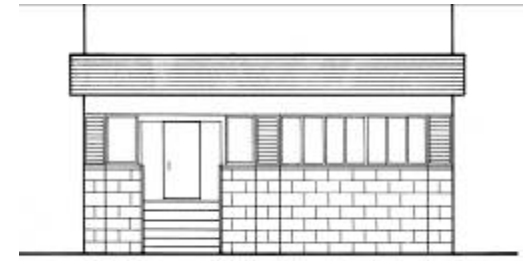
Porch filled in, inconsistent with character of the building..

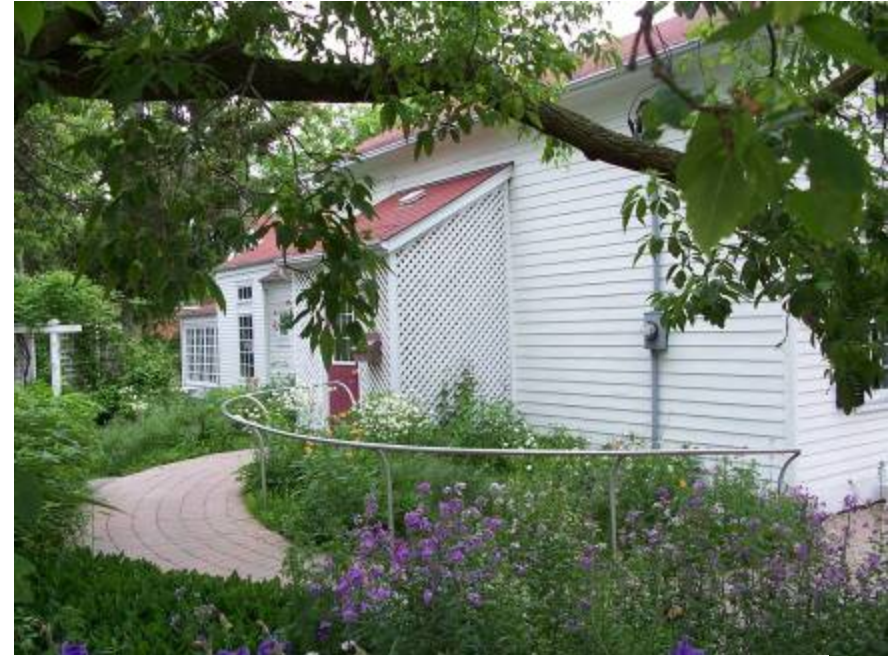
The access ramp at the Thornhill Village Library is discretely integrated with the landscaping, and does not detract from the historic building.

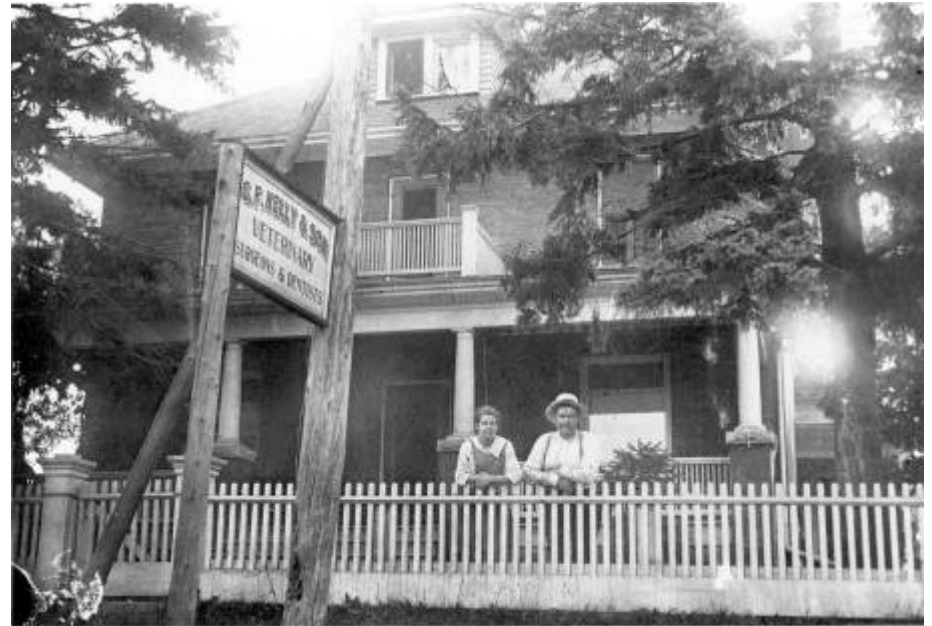
Wood picket fences and mature vegetation, as shown here at Dr. Kelly's, residence, provides an appropriate and attractive context for heritage buildings. Casella #49.

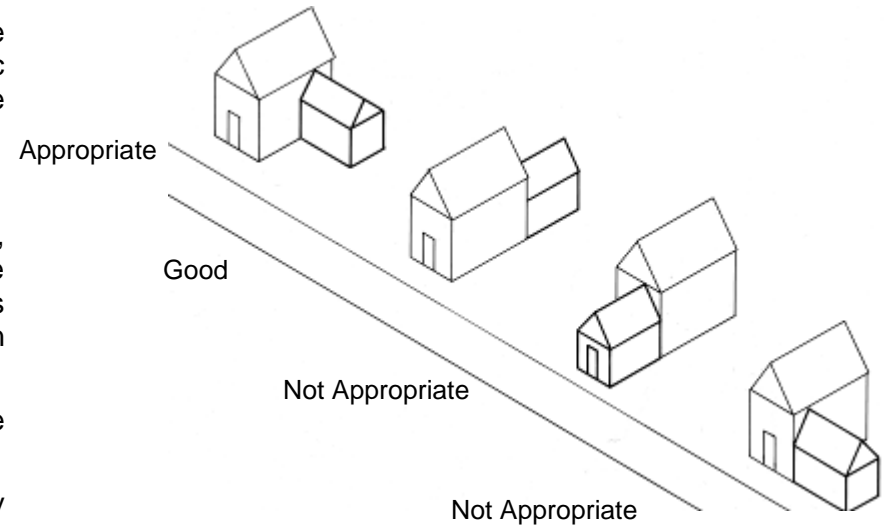
Appropriate: addition in rear
